Channel Stability Problems, Pajaro River, Watsonville and Pajaro, California

**U.S. Army Engineer Committee on Channel
Stabilization Report of the 63rd Meeting**

ERDC/CHL SR-00-3
CCS-00-1
August 2000

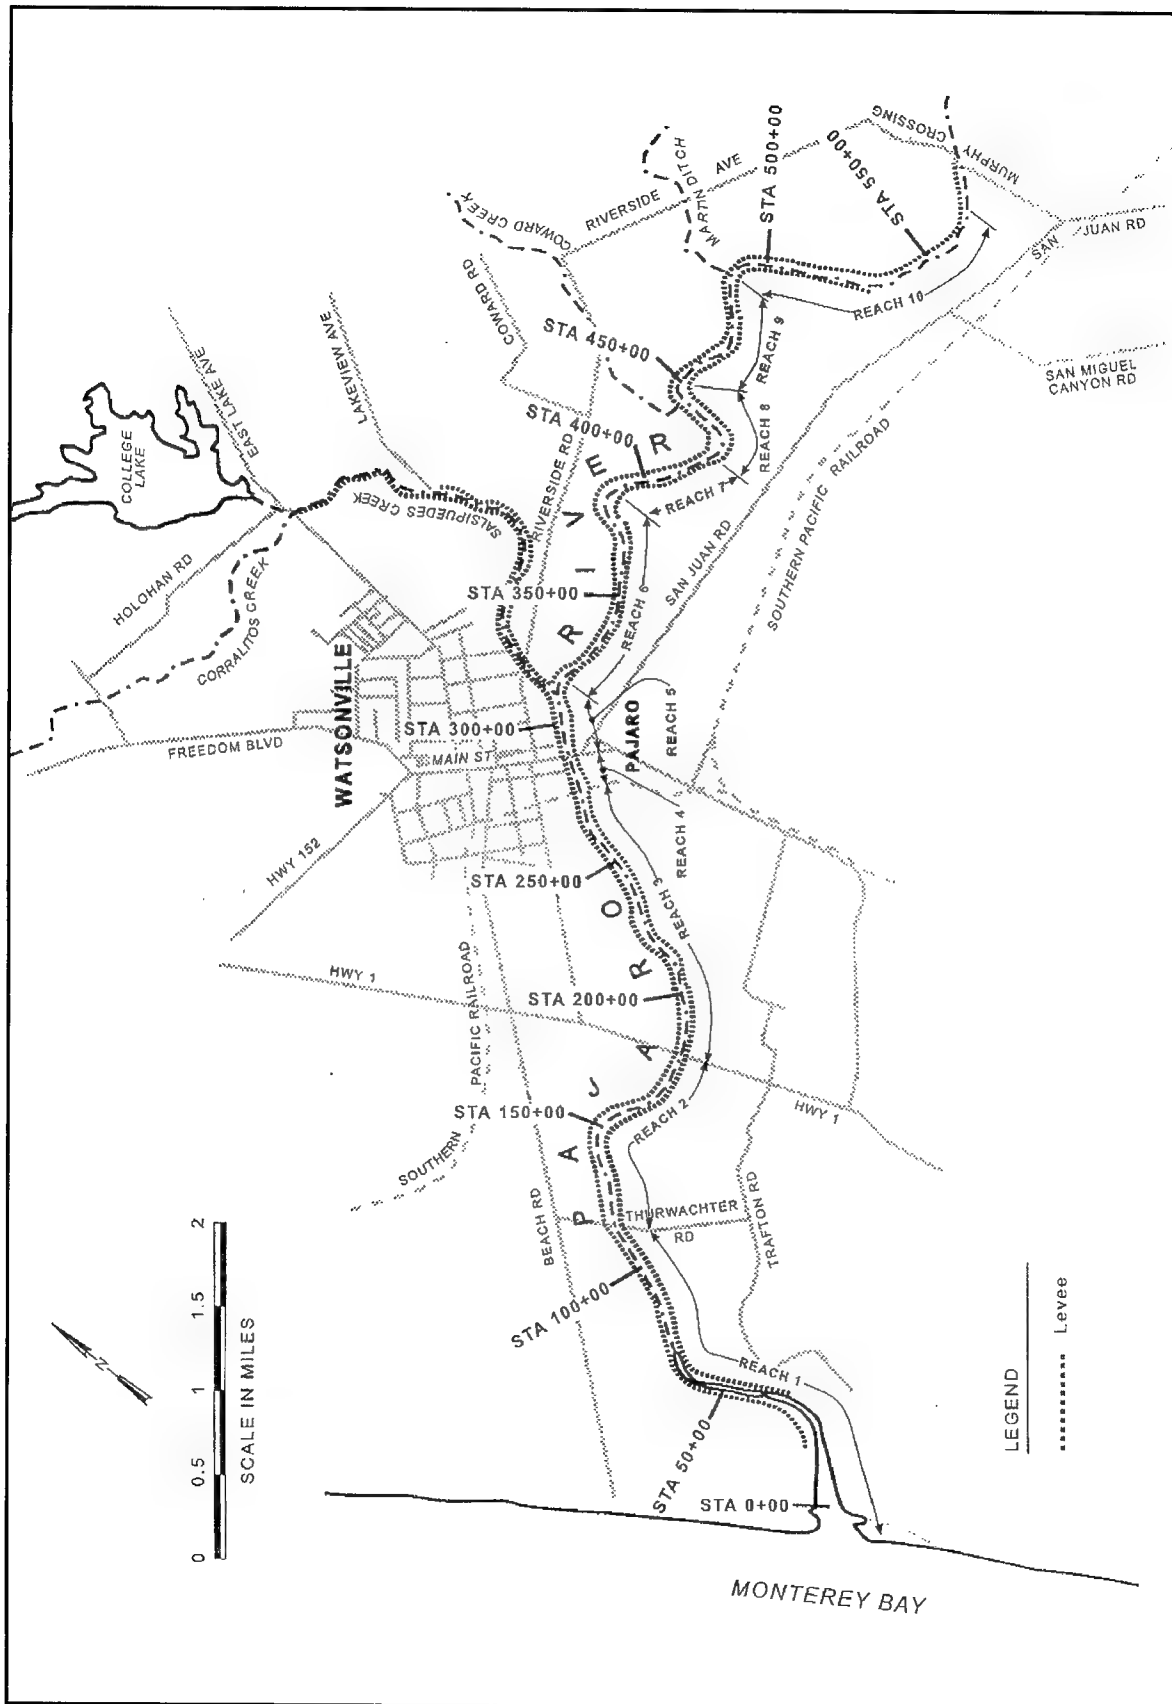
Figure 5. Location map

- a. Based upon the information provided in the pre-inspection briefing and field observations, it would appear that the high banks have eroded past the “original” high bank in a relatively few locations. (Figure 5) these are: (1) Sta 132+00 to 142+00 RB; (2) Sta 164+00 to 166+00 LB; (3) Sta 176+00 to 178+00 LB; (4) Sta 219+00 to 224+00 RB; (5) Sta 243+00 to 247+00 LB; (6) Sta 275+00 to 276+00 LB; (7) Sta 296+00 to 297+00 LB; (8) Sta 323+00 to 324+00 LB; (9) Sta 333+00 to 345+00 LB; (10) Sta 374+00 to 376+00 RB; (11) Sta 415+00 to 417+00 LB; (12) Sta 422+00 to 423+00 LB.

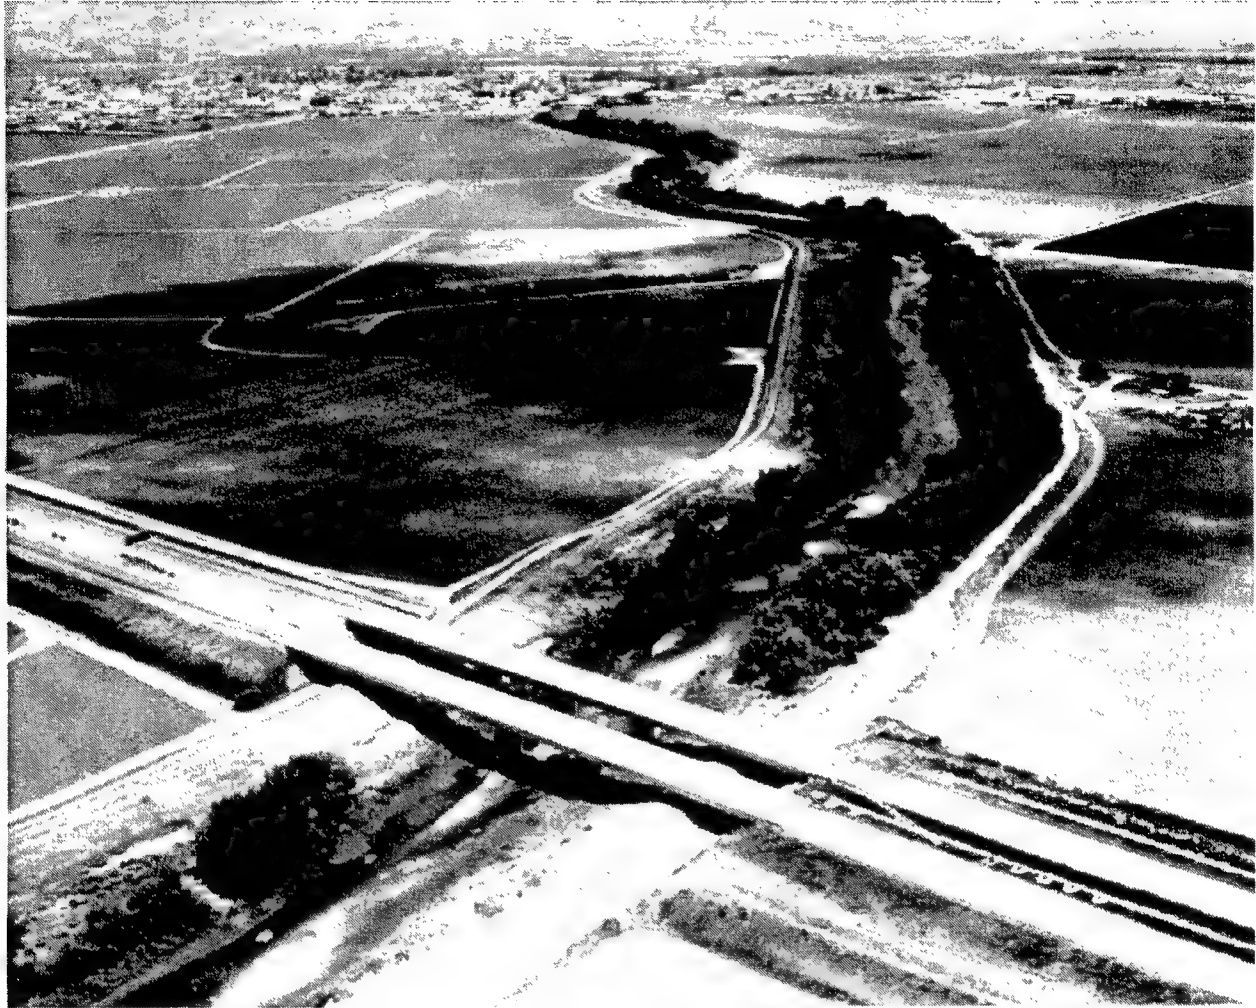
Plate 3
Aerial View of Project at Highway 1, June 1971

on Plate 2 shows a footprint of the levee project, the photograph on Plate 3 (dated June 1971) shows an aerial view of the project at Highway 1.
